## 1962 THROUGH 1972 TACH DRIVE DISTRIBUTOR RESTORATION

By [Dave Fiedler](#)

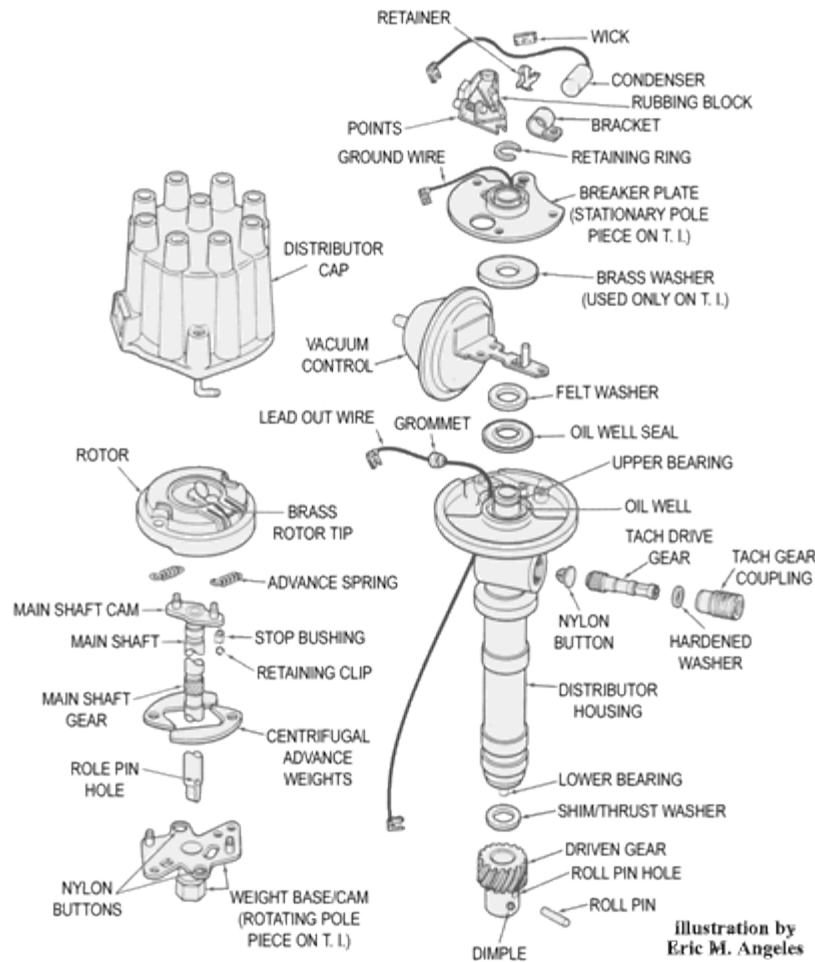
**1962 - 1972 CORVETTE TACH DRIVE DISTRIBUTOR**

- A. Main shaft gear and tach drive gear- The most common problem is sheared gear teeth on both parts. This is usually accompanied by excessive tach drive gear end clearance (also see items [C](#) & [F](#)).

- B. Main shaft and lower bearing- The bearing is usually worn to an oval shape due to the side thrust produced by the drive (cam) gear. When wear is present the bearing will have circumferential grooves that are mirrored in the main shaft.

- C. Distributor housing where tach drive gear contacts the inside surface- The tach drive gear is heat-treated steel, which makes it very hard, unlike the cast iron housing which is relatively soft. Due to marginal lubrication and the thrust load produced from two mating gears (which is in the direction of the housing) the hardened tach gear bores a hole into the soft housing creating excessive end clearance. Note, for mid-1970 and newer distributors, including service distributors, Delco addressed this problem by making a minor change to the

housing. The fix was a nylon button that was added in such a way that the tach gear would bear against it. This redesign is easily detected since it is accompanied by a thru hole in the housing that is necessary to locate the nylon button.

- D. Advance weights/main shaft cam interface- this fretting type wear is caused by almost constant relative motion between these two parts and is aggravated by a lack of lubrication. The wear, if present, will be visible as indentations at the points of contact.

- E. End of distributor housing where the driven gear shim contacts cast iron surface- For various reasons this surface is sometimes scored and worn in an irregular pattern. A poor bearing surface at this location can usually be seen by looking at the shims that mate with the housing. The shims will show non-uniform contact.

- F. Main shaft centerline to tach drive gear centerline problem- This is not a wear problem, but it is a condition that exists in an estimated ten percent of tach drive distributor housings. The problem is that the centerlines were machined too closely by Delco, causing abnormal wear between the main shaft gear and the tach drive gear. Deformed or sheared teeth on both gears can be a result of this problem. Assuming the upper and lower bearings are within specification, it is best identified by installing a new main shaft, coupling and tach drive gear into the housing and then rotating the main shaft to check for binding. The main shaft should turn freely in both directions.

- G. Bearing misalignment- This is a condition where the upper and lower bearings are not on the same centerline. This condition can be detected by slowly sliding a new main shaft through a good top bearing and into the lower bearing. If there is misalignment you can feel the shaft hit the edge of the lower bearing and when fully inserted the shaft will not turn freely.

- H. Vacuum controls- This is not an obvious wear issue, but it is what you cannot see that could create a problem. The rubber diaphragm inside the crimped housing develops tears that will cause the control to not actuate and it will also allow air to enter the engine (vacuum leak.) For this reason, old vacuum controls do not tend to be very reliable and they are usually not cosmetically attractive.

- I. Weight base/cam (on point-style distributors)- Inspect the cam for wear caused by the rubbing block on the points pivot arm.

**Solution:** If the main shaft and tach drive gears are sheared then replacement is the only solution. When the main shaft is replaced it is extremely important to use a shaft that has the same cam brazed onto the end. GM used (38) different main shaft cams in tach drive distributors from 1962 to 1972. This cam is fundamental to the centrifugal advance curve because it determines the shape of the curve as well as controlling other functional characteristics (see article "[All TI Distributors Are Not Equivalent](#)" THE CORVETTE RESTORER Vol. Twenty-One, Number One, Summer 1994). If an identical main shaft cannot be found, the original cam should be removed and brazed onto a good shaft. One should be careful to orient the cam in the same angular position (with respect to the roll pin hole) as it was on the original main shaft. Caution: It is possible that substituting a main shaft with a different cam will have a detrimental effect on the performance of the vehicle.

**Solution:** Main shaft wear is usually restricted to the area in contact with the lower bearing. Minor circumferential grooves can be removed from the main shaft by using fine grit abrasive tape and a lathe or similar means to rotate the shaft while polishing. An original main shaft is .489" in diameter- this diameter should not be reduced during polishing by any more than .001" in the area of the bearings. If the main shaft is heavily scored, then it will be necessary to replace it (see [Solution A.](#)) For bearing replacement, the lower bearing can be driven from the housing with a suitable drift. The housing should be measured to determine what size of bearing is needed. Delco machined the housings anywhere from .639" to .645" in diameter. A bearing with an outside diameter of .002" greater than the housing bore should be pressed into place and then reamed to the proper clearance- .0005" to .002" larger than the main shaft diameter. Bearing material should be bearing bronze not Oilite, brass or silicon bronze. Note: Upper bearings have not been mentioned because they generally see very little wear since there are no side forces acting on them. If an upper bearing needs to be replaced follow the same procedure outlined for the lower bearing.

**Solution:** Although there are many ways to repair this problem, most of the solutions destroy the originality of the housing. One method that preserves the originality involves the use of a custom-made spacer that is attached to the end of the tach gear. The procedure goes as follows: The distributor housing is set up in a Bridgeport-type mill so that the tach drive cavity worn area is perpendicular to the axis of the tach drive gear. The damaged area is then milled to produce an unblemished bearing surface. Next the tach gear, washer and coupling are installed in the housing and the distance between the end of the tach gear and the new surface that was generated is determined. The last step is to custom make a spacer from bearing bronze to a thickness that will allow .010" endplay in the tach drive gear. Since this spacer is held in place by the tach gear, a hole must be drilled in the end of the gear so that a protrusion on the spacer can be pressed into the gear.

**Solution:** Since the main shaft cam is so important, as previously discussed, every effort should be taken to restore the original cam. Shallow indentations can usually be removed by using a die grinder with a fine grit wheel to uniformly remove material while maintaining the original contour. The surface should then be polished with a sanding roll. Advance weight contact point indentations can also be ground smooth, however if much stock removal is required (which would alter the geometry of the weight) the result would be a change in the advance curve. If that is the case, the advance weights will have to be replaced using the correct style (four different part numbers were used. )

**Solution:** When this surface is scored or worn unevenly, the only solution is to machine the housing (using a lathe) in order it to get a good bearing surface.

**Solution:** If the centerline spacing is marginally out of specification, select fit of parts (coupling, tach gear and main shaft) may solve the problem. Otherwise, the only solution is to have the housing machined correctly. Since the position of the tach gear is already determined, or at least very difficult to change, the only option is to shift the main shaft centerline. This has to be done by a very competent machine shop that can jig bore the bearing bores in the housing to the specified center to center distance of .425". Oversized bearings (on the outside diameter) will have to be made to fit the bores. Ream the I.D. of the bearings as in [Solution B](#). **This procedure is very tedious and would significantly add to the cost of a restoration.**

**Solution:** The housing will have to be jig bored in a fashion similar to [Solution F](#); only this time the objective is to correct the alignment of the bearing bores while maintaining the correct tach gear to main shaft centerline distance. **Again very tedious.**

**Solution:** Replacing vacuum controls presents a dilemma, as GM/Delco stopped making vacuum controls in 1994. An outside source currently makes all the controls and they are packaged under the Delco name. Unfortunately, these controls do not look like and are not numbered like the originals. Originals were stamped with the last three digits of the seven digit GM part number. These three digits were followed by another number that indicated the total amount of advance the control would provide. Current controls are stamped with a *B* followed by a number that has no functional significance. Some reproduction controls are available which look very similar to the originals, but they miss the target on function. Best advise- look for N.O.S. vacuum controls.

**Solution:** Minor score marks can be removed from the cam by using a 3M Scotch-Brite deburring wheel or equivalent abrasive. Replace the weight base/cam if the score marks cannot be removed or if the cam lobes are worn below .987” diametric reading from peak to peak. Note: If this part needs to be replaced use an identical part- check and compare the three digit stamped-in code number. Ten different part number weight base/cams were used.
